## AVIATION INVESTIGATION REPORT

A01W0129

### LOSS OF SEPARATION

NAV CANADA  
EDMONTON AREA CONTROL CENTRE  
EDMONTON, ALBERTA  
31 MAY 2001

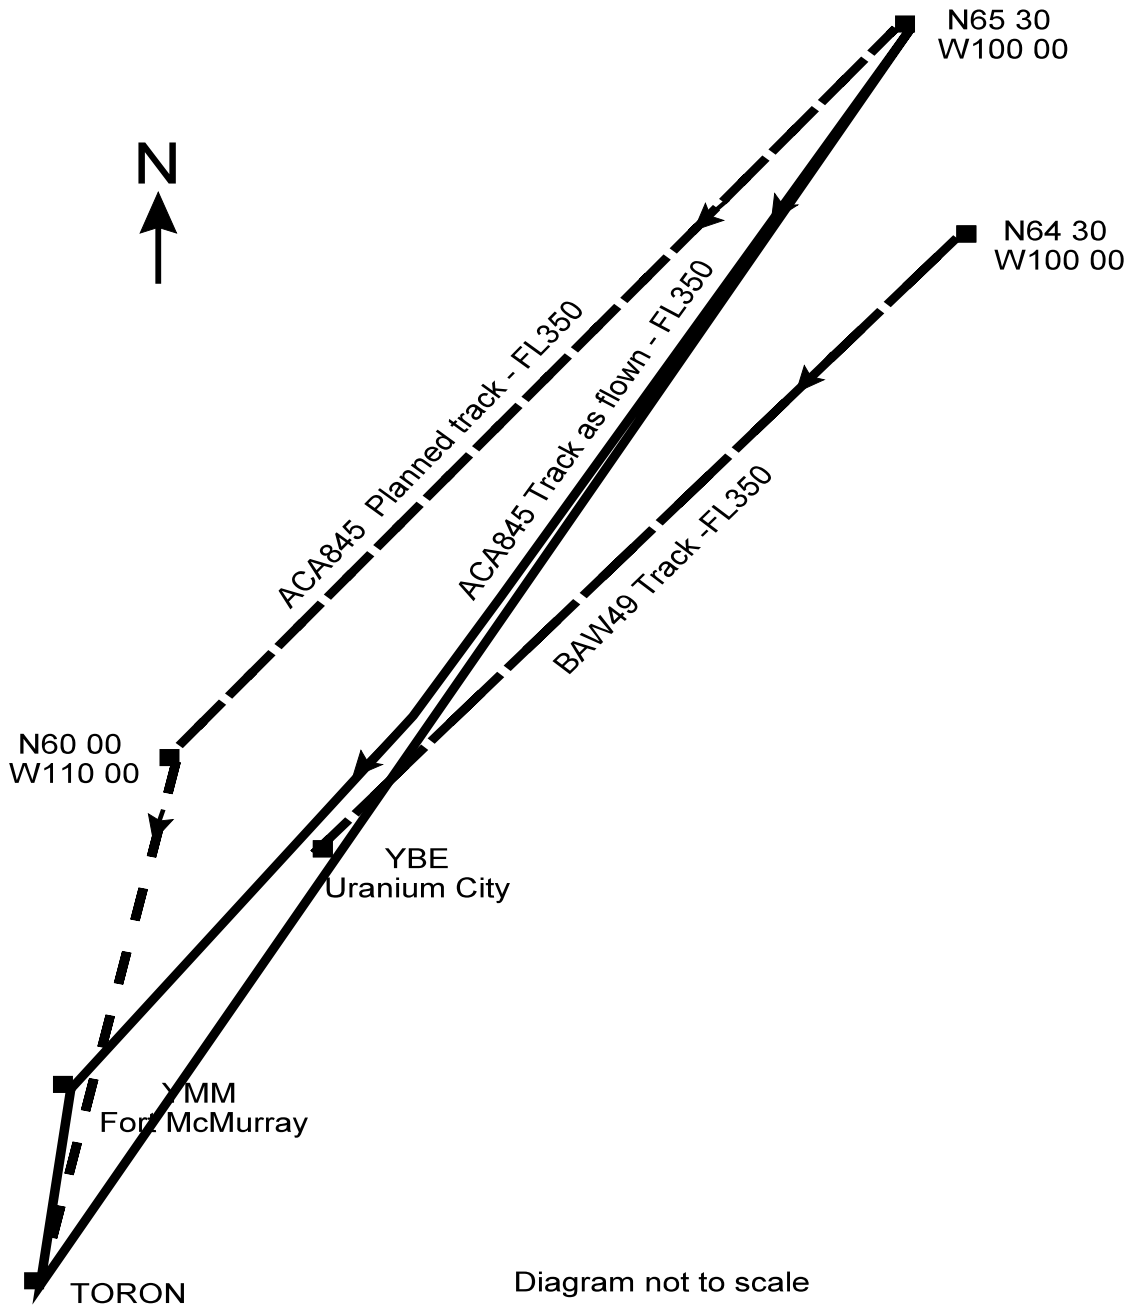
# Appendix A—Aircraft Tracks

ACA845 proceeded from 6530N100W direct to TORON as it had been cleared. BAW49 was on a converging track from 6430N100W to Uranium City (YBE), Saskatchewan. Both aircraft observed each other on the traffic alert and collision-avoidance system (TCAS) and visually. The flight crew of ACA845 contacted BAW49 directly because the two aircraft were out of the Franklin sector's VHF radio range, and it was evident that the aircraft were going to cross paths. ACA845 paralleled BAW49's flight for approximately five minutes until they were able to contact the Bison sector controller directly via the assigned VHF frequency.

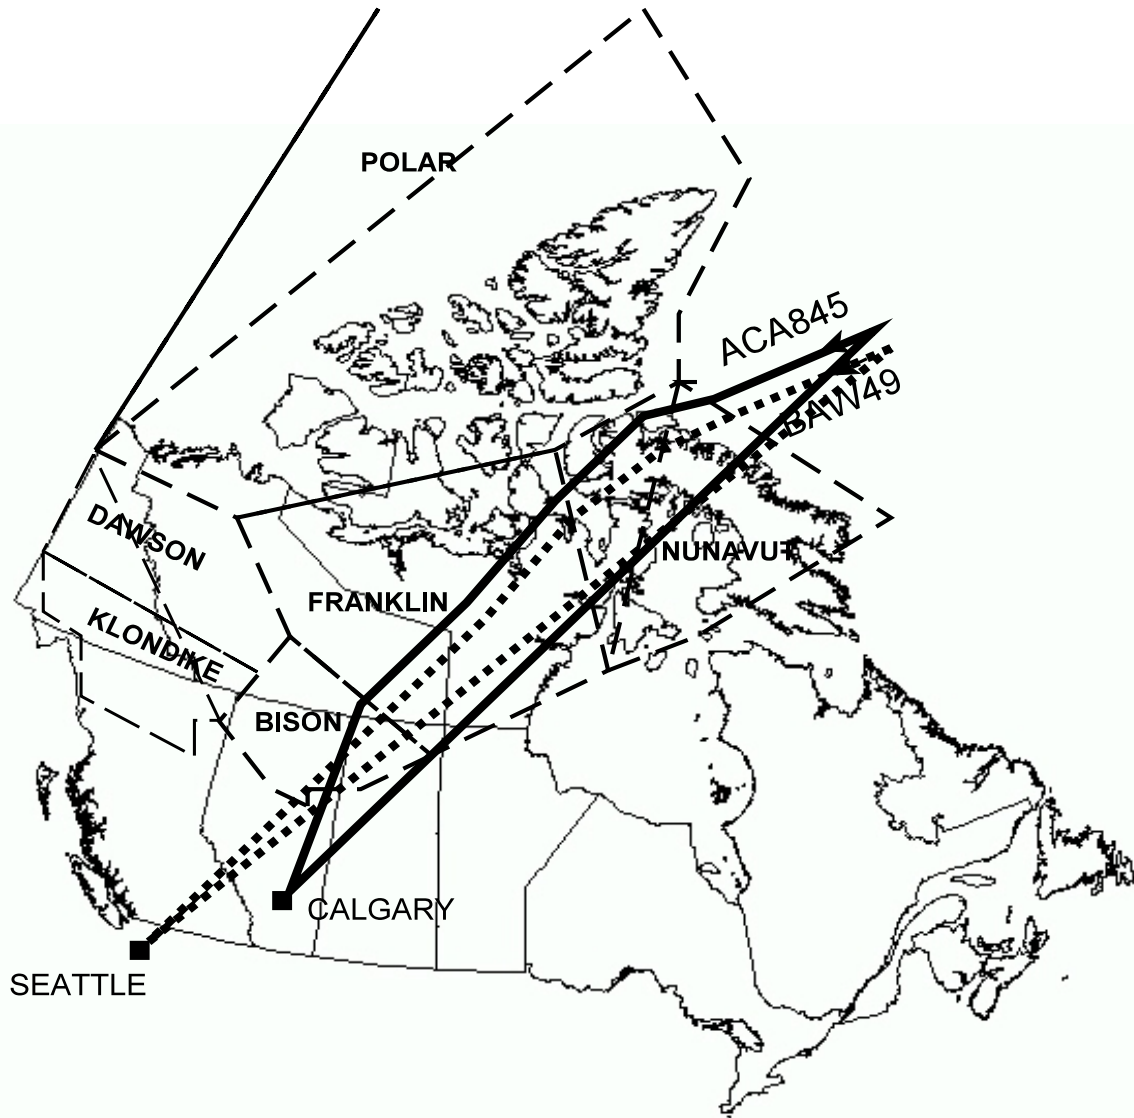
*Appendix B—Sector Boundaries and Original Flight-Planned Tracks*

The north high specialty of Edmonton Area Control Centre (ACC) consists of five sectors that use procedural (non-radar) separation standards and one sector (Bison) that provides procedural and radar control. (See Appendix B.) Aircraft in the procedural control areas are separated by assigning specific routes and altitudes for the aircraft to fly. Confirmation of separation is provided by periodic position reports, which are typically passed by flight crews every 10° of longitude or over mandatory reporting points. Depending on the location of the aircraft, these reports are received by the controllers in one of two ways. In the Far North, reports are routed through very high frequency (VHF) or high frequency (HF) remote communications outlets (RCOs) to Arctic radio specialists in North Bay, Ontario. The information is then relayed to the Edmonton controllers via landlines. Further south, flight crews provide position reports via VHF RCOs that are directly accessible by Edmonton controllers.

processes position reports, and transfers communications. The data controller receives and forwards estimates with adjacent units/sectors, amends strips as required, and assists with the flow of traffic within a sector. At the time of the occurrence, the north high specialty was handling mostly westbound traffic from Europe headed for the western parts of North America. (See Appendix B.)
